COMMUNITY DEVELOPMENT AUTHORITY MEETING  
CITY OF WISCONSIN DELLS  
APRIL 24, 2017

# INSPECTION REPORT

321 Broadway Ave.  
Wisconsin Dells, Wisconsin 53965

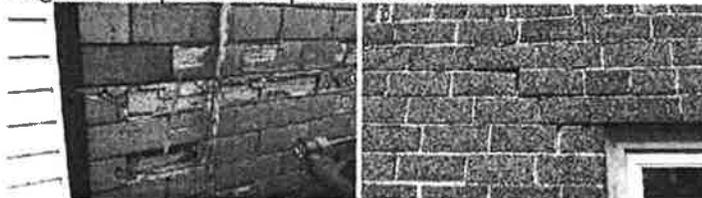
3. Marginal **Type:** Block: There is some damaged blocks observed at the rear of the building and some step cracks visible at the sides. Recommend further evaluation by a contractor or structural engineer for possible repair estimates.

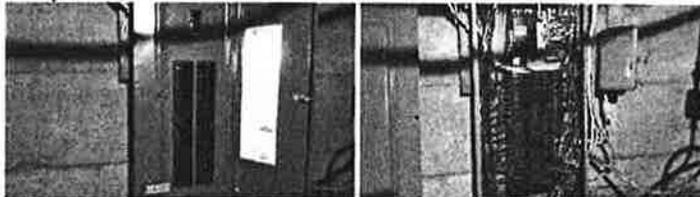
**Basement Electric Panel**

- 7. Marginal **Manufacturer: Square D:** There is obstructed access, there needs to be clear access to the panel.

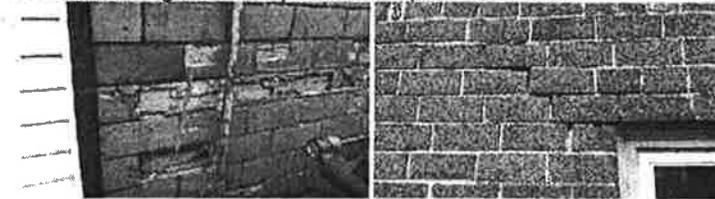
- 2. Sides and rear Exterior Surface Type: Block:** There is some damaged blocks observed at the rear of the building and some step cracks visible at the sides. Recommend further evaluation by a contractor or structural engineer for possible repair estimates.

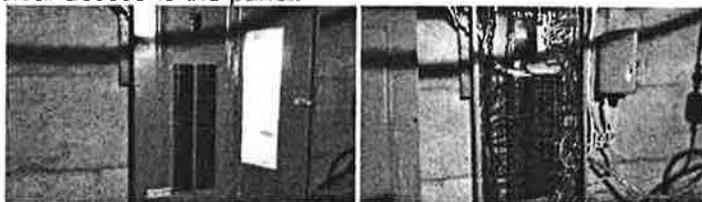
- 5. Basement Electric Panel Manufacturer: Square D:** There is obstructed access, there needs to be clear access to the panel.
